BRISTOL FISH AND GAME CLUB DAM
CT-00299

PHASE I INSPECTION REPORT

NATIONAL PROGRAM OF INSPECTION OF DAMS

Name of Dam:	BRISTOL FISH AND GAME CLUB DAM
Inventory Number:	CT 00299
State:	CONNECTICUT
County:	NEW HAVEN
Town:	WOLCOTT
Stream:	CUSSGUTTER
Owner:	BRISTOL FISH AND GAME CLUB
Date of Inspection:	APRIL 29, 1981
Inspection Team:	PETER M. HEYNEN, P.E.
	MURALI ATLURU, P.E.
	JAY A. COSTELLO

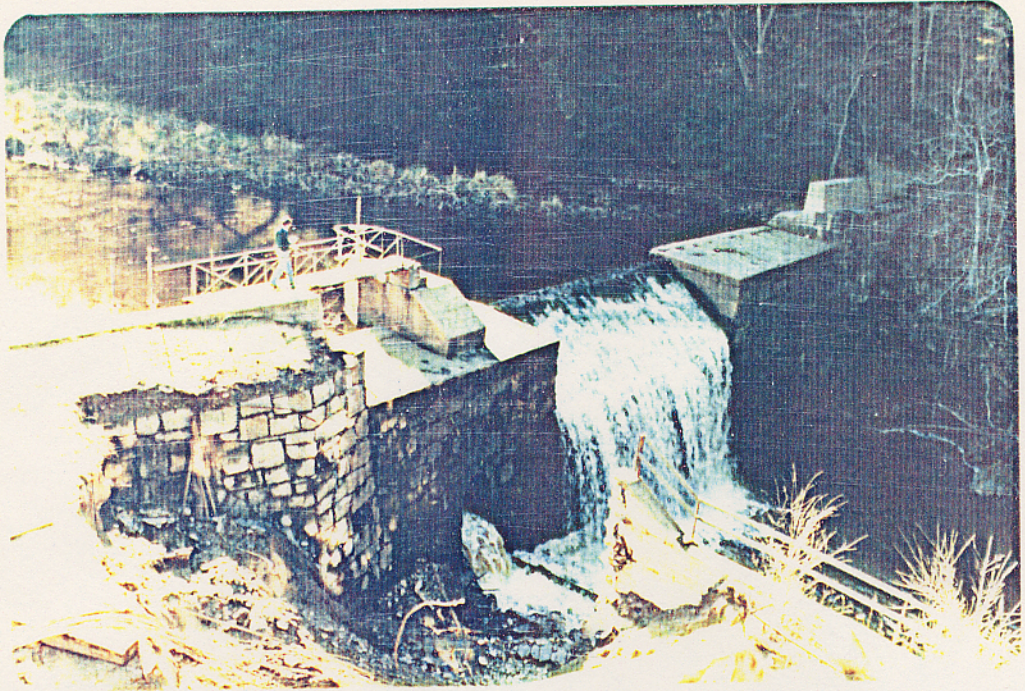
PHOTO NO. 1

OVERVIEW OF DAM FROM DOWNSTREAM SIDE

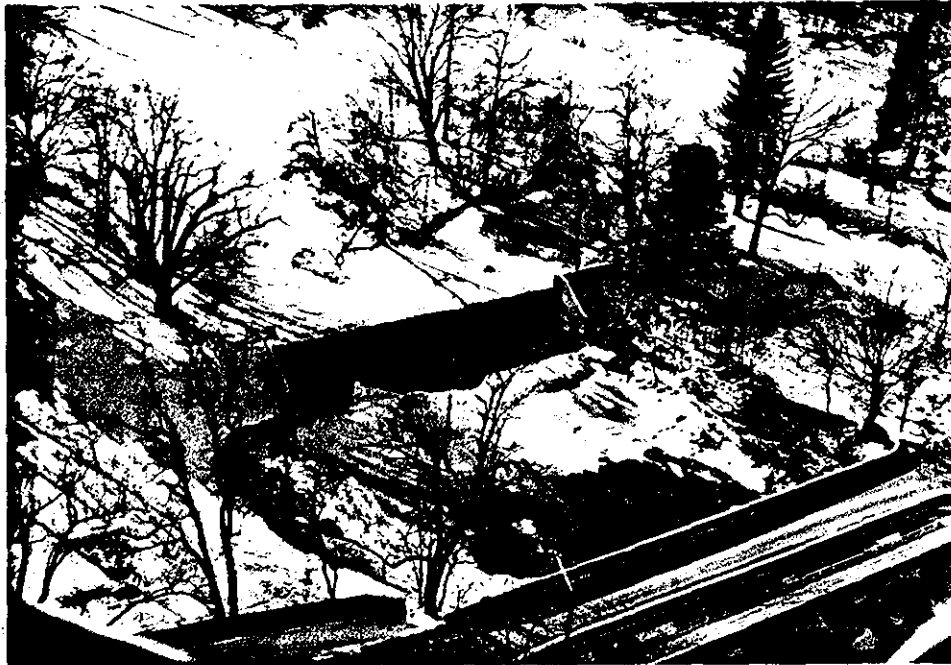
Based on visual inspection, the Schwartz Pond Dam is judged to be in fair condition. A feature found existing that could affect the stability of the dam is the deteriorating concrete at the wingwalls, regulating outlet and west dam embankment.

It is recommended that the owner arrange for a qualified registered engineer to do the following within one year of receipt of this report:

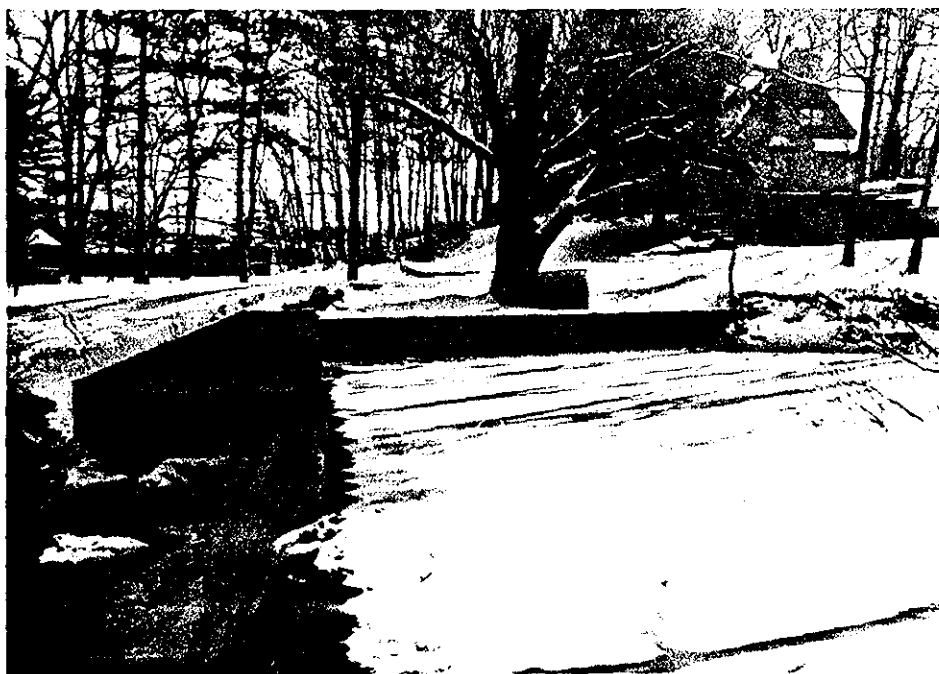
The concrete spillway was generally in good condition as shown in Photos 2 and 3. Exposed coarse aggregate along the spillway and two minor cracks on the crest were observed as noted on the general dam plan in Appendix B. Any seepage that may flow through or under the spillway could not be inspected due to the water flowing over the spillway.

channel. A wooden sluice gate is located at the entrance of the outlet and controlled by an iron winch, which is situated on top of the eastern dam embankment (See Photo 3).

Photo 3 - View looking east across spillway.

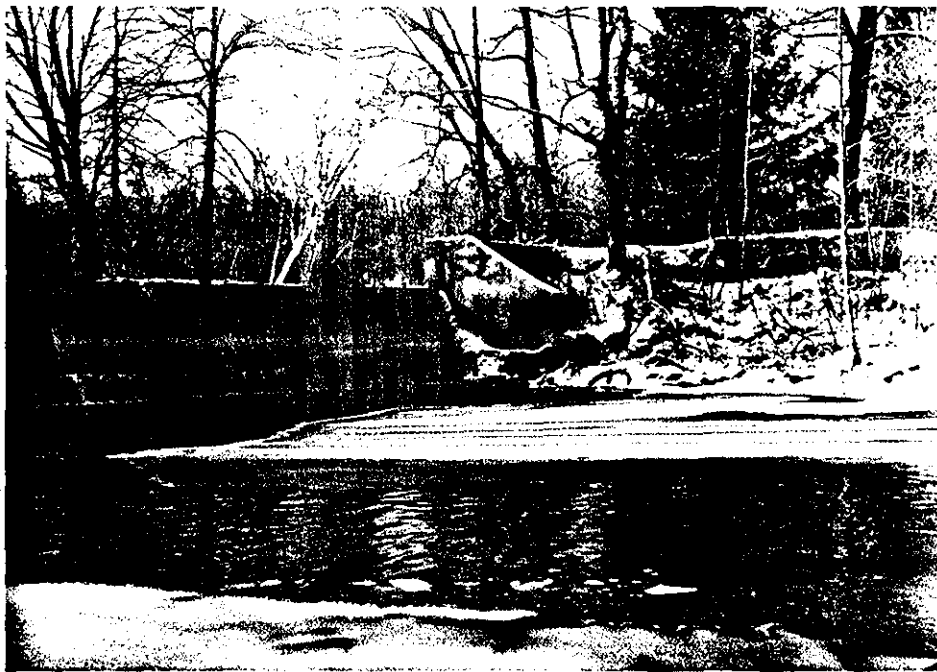
As shown in Photo 5, the concrete wingwall west of the spillway was in fair condition with no visible cracks. The bottom portion of the wingwall appeared to have been recently repaired with no apparent voids underneath; however, the north end of the wingwall did show signs of continuing deterioration (See Photo 7). At the junction of this wingwall and the west concrete dam embankment, moderate deterioration was observed as shown in Photo 6. Some efflorescence was also noted at the construction joints of the west dam embankment as shown on the general dam plan in Appendix B. The area

Photo 5 - View of spillway and west wingwall.

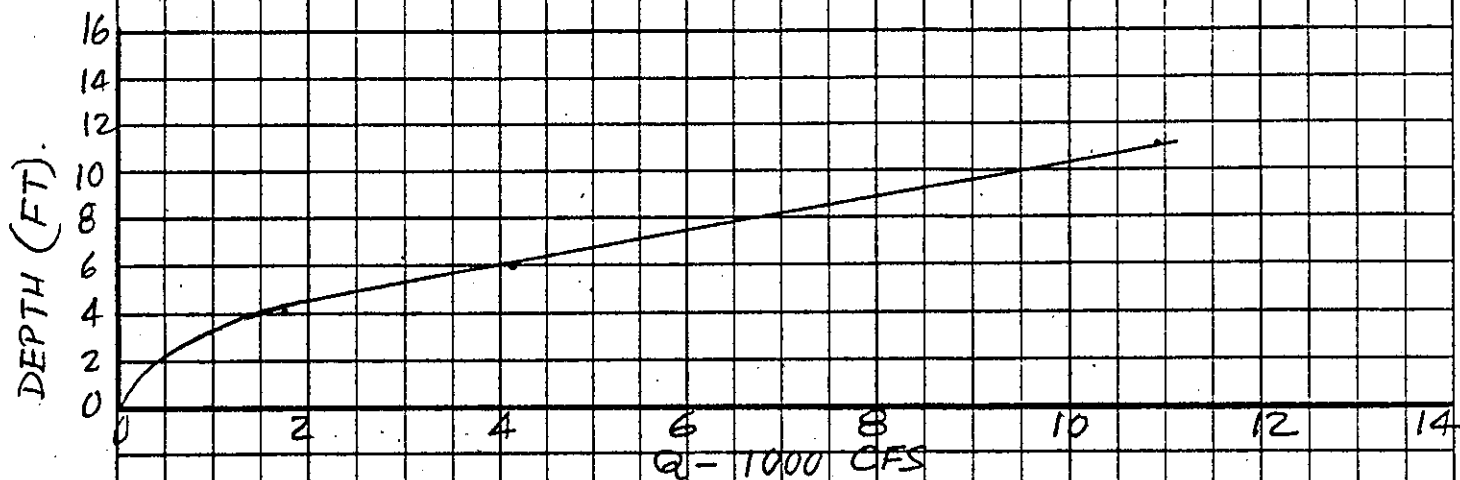
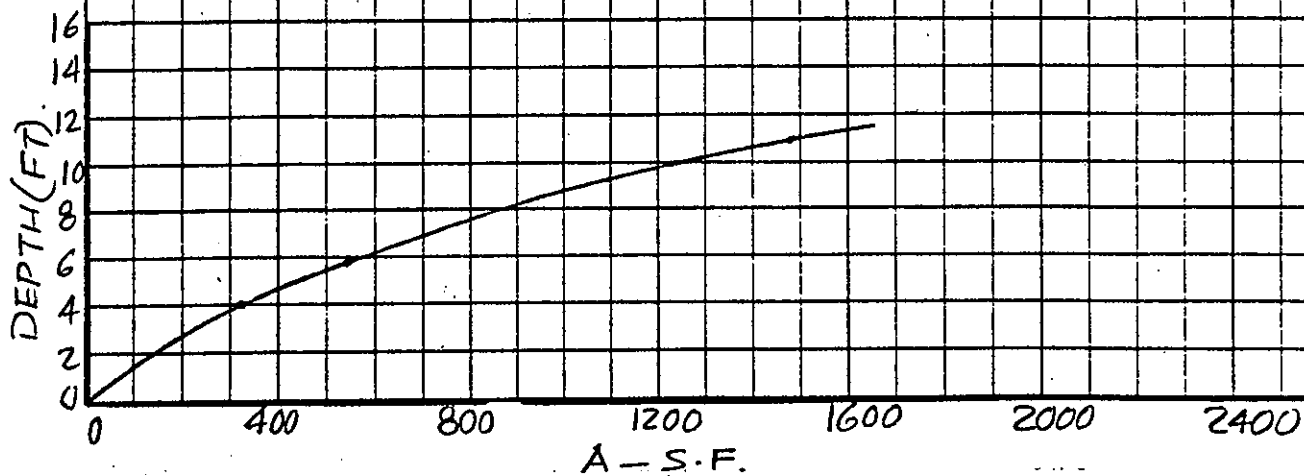
X-SECTION #3 STA. 50+0

ELEV. (FT.)	D (FT.)	P _w (FT.)	A (S.F.)	R = A/P _w (FT.)	S (FT/FT)	V = $\frac{1.486}{n} R^{2/3} S^{1/2}$ (FT/SEC)	Q (CFS.)
63.0	4.0	110	320	2.91	↓	5.48	1750
65.0	6.0	120	550	4.58	0.004	7.42	4080
70.0	11.0	330	1490	4.52	↓	7.35	10950
